**DYNAMIC SCIENCE, INC.**  
In-Depth Accident Investigation

Contract Number DTNH22-93-P-07049  
Case Number DSI-93-AB-018

## TECHNICAL SUMMARY

[REDACTED]  
[REDACTED]  
This two vehicle collision occurred on a two lane, divided, residential roadway, on a summer, weekday afternoon in [REDACTED], Virginia. ([REDACTED]-93) The case was initiated as an alleged airbag non-deployment in a serious crash.

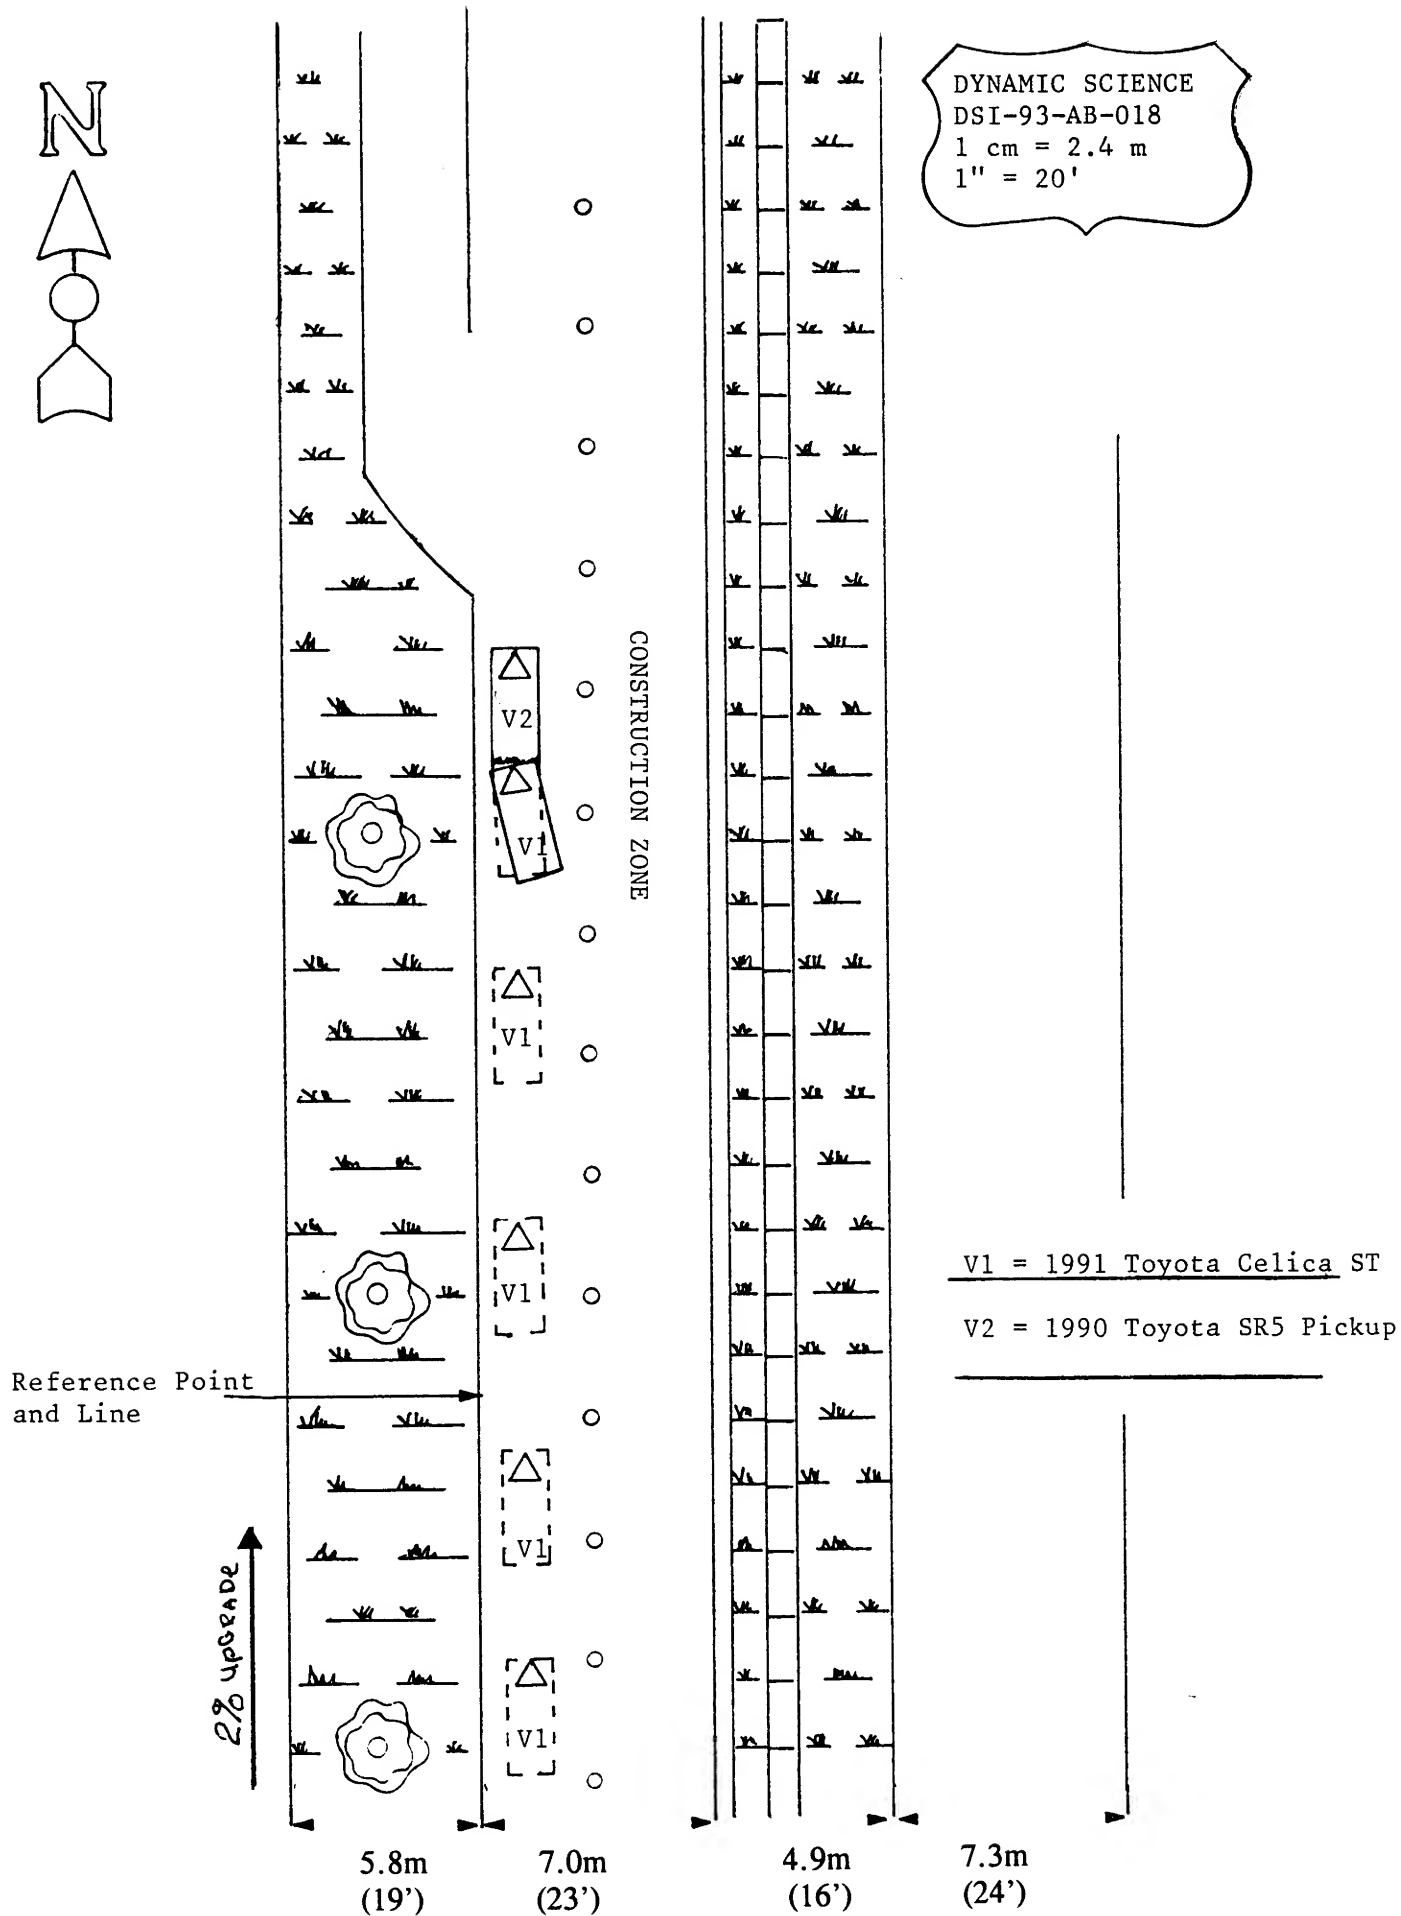
DYNAMIC SCIENCE  
DSI-93-AB-018  
1 cm = 2.4 m  
1" = 20'

## **COLLISION MEASUREMENTS**

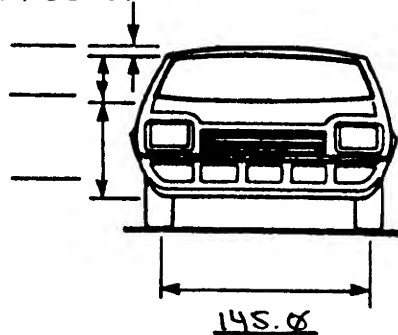
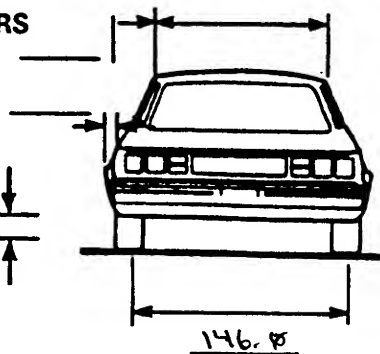
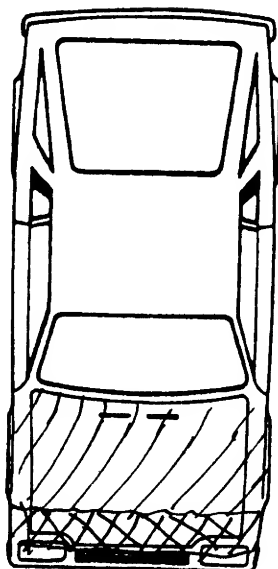
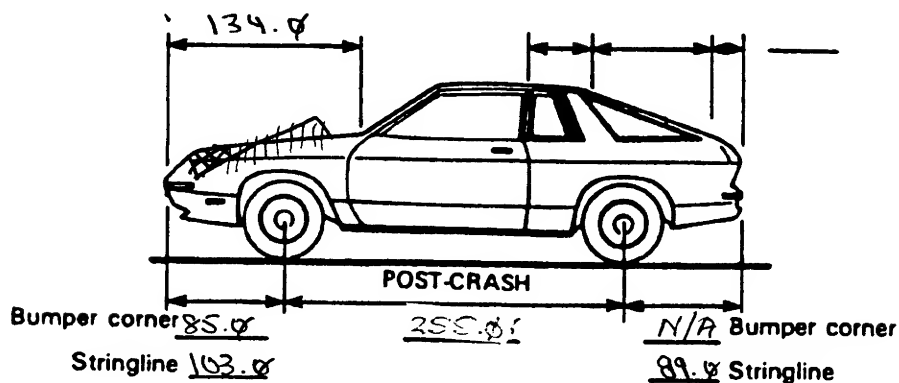
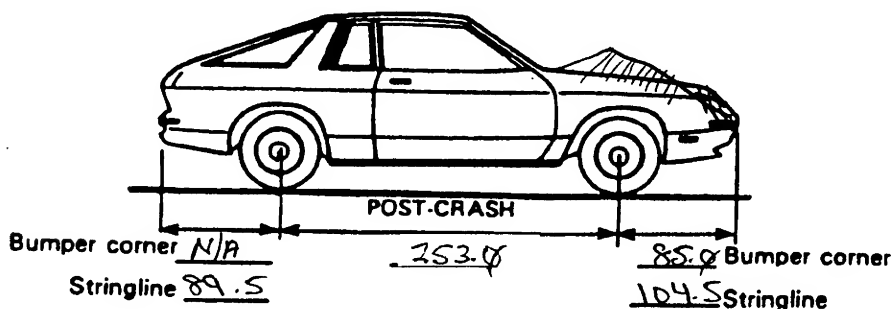
## VEHICLE DAMAGE SKETCH

Specific Impact Number	Plane of Impact C-Measurements	Direct Damage		Field L	C <sub>1</sub>	C <sub>2</sub>	C <sub>3</sub>	C <sub>4</sub>	max C <sub>5</sub>	C <sub>6</sub>	±D
		Width (CDC)	Max Crush								
<u>Ø 1</u>	<u>ABOVE Bumper</u>	<u>144.Ø</u>	<u>41.8</u>	<u>126</u>	<u>29.8</u>	<u>19.2</u>	<u>42.5</u>	<u>39.Ø</u>	<u>41.8</u>	<u>41.4</u>	<u>Ø</u>
	<u>- FREE SPACE</u>		<u>4.Ø</u>		<u>13.Ø</u>	<u>4.Ø</u>	<u>Ø</u>	<u>Ø</u>	<u>4.Ø</u>	<u>13.Ø</u>	
	<u>- ADD FREE SPACE</u>		<u>14.Ø</u>		<u>16.8</u>	<u>14.Ø</u>	<u>20.Ø</u>	<u>20.Ø</u>	<u>14.Ø</u>	<u>16.8</u>	
	<u>RESULTANT</u>		<u>33.8</u>		<u>Ø</u>	<u>1.2</u>	<u>22.5</u>	<u>19.Ø</u>	<u>33.8</u>	<u>11.3</u>	
			<u>Ø C-5</u>								
<u>Ø 1</u>	<u>Bumper</u>	<u>144.Ø</u>	<u>N/A</u>	<u>126</u>	<u>13.Ø</u>	<u>4.Ø</u>	<u>20.Ø</u>	<u>20.Ø</u>	<u>4.Ø</u>	<u>13.Ø</u>	
	<u>- FREE SPACE</u>				<u>13.Ø</u>	<u>4.Ø</u>	<u>20.Ø</u>	<u>20.Ø</u>	<u>4.Ø</u>	<u>13.Ø</u>
